MASTER CARPENTRY CASE STUDY www.FirethornOnline.com

St. Stephen's Episcopal Church Florence, New Jersey

Having Faith.

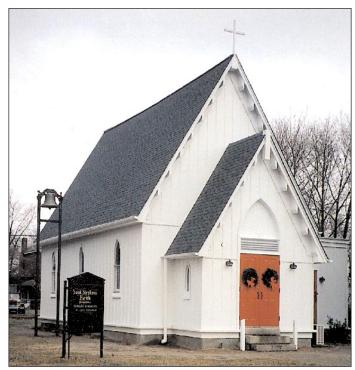
During the fire repairs, it was discovered that the sill plates had suffered from insect infestation, rot, and age. But replacing them wouldn't be easy, as the wooden structure of the Church sat on a foundation above a very tight crawlspace. This required crawling underneath the structure and leveling areas of the earth by hand to set the hydraulic jacks properly.

Surgical precision was necessary to carefully elevate the historic structure. One manageable section was elevated at a time to ensure that the exterior wall structure was supported and that the interior plaster would not crack or fail. Once elevated, the decayed sill plate was removed and replaced with new timber. Jacks were slowly released to ease the building back down, and the surrounding structural members were attached to the new sill plate. This process was repeated section by section until all the damaged structure was replaced.
